# CONFIDENTIAL INSPECTION REPORT

**0000 BELLEAU WOODS, IL 00000**

**Inspection Date: November 10, 1775**

**A SPECIALIZED DIVISION OF**  
**ALLIED HOME INSPECTORS, LLC**

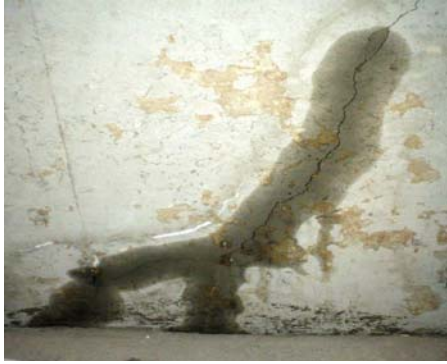
**ACTIVE WATER INFILTRATION AT SOUTH FOUNDATION WALL CRACK**

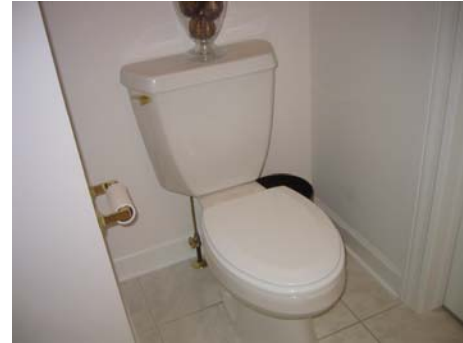
**TOILET IN MASTER BATHROOM IS LOOSE AT BASE, SEAL LEAKING**

ITEM INSPECTED	DESCRIPTION	REMARKS
Toilets	Appear Serviceable	Toilet in master bathroom is loose at the floor and shows signs of past water leaking. Suggest replacing wax seal and properly sealing toilet to floor.
Sinks	Appear Serviceable	Drain stops operational
Bathtubs	Appear Serviceable	No drain stop present in 2nd floor hall bathroom.
Whirlpool Tub	None	N/A
Showers	Appear Serviceable	Water diverters operational
Ventilation	Appear Serviceable	Improperly vented into attic
GFCI Protection	Appear Serviceable	Suggest monthly testing of all GFCI outlets as a safety precaution.

Toilets that are loose at the base or at the tank connection pose the possibility of leaking. Sometimes the wax seal at the floor must be replaced to prevent leakage.

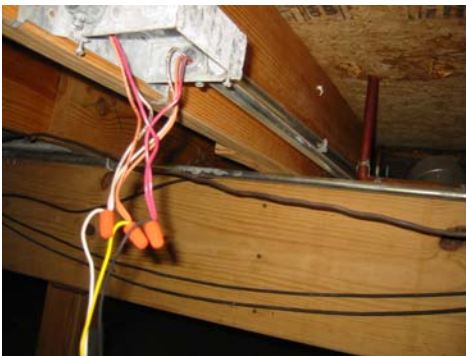
**EXPOSED HIGH VOLTAGE WIRING OPEN JUNCTION BOX AT BASEMENT CEILING**

- **Double tapped circuit breaker observed in main panel. Recommend repair by a qualified electrician.**
- **Exposed wiring observed in attic and basement. Recommend all exposed wiring be properly concealed.**

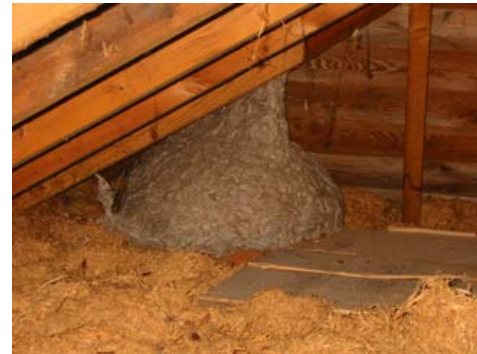
**LARGE HORNETS NEST LOCATED IN ATTIC**

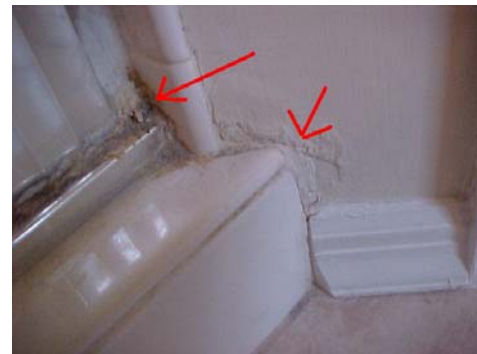
**WATER LEAK AND WALL DAMAGE AT HALLWAY BATHROOM SHOWER BASE**

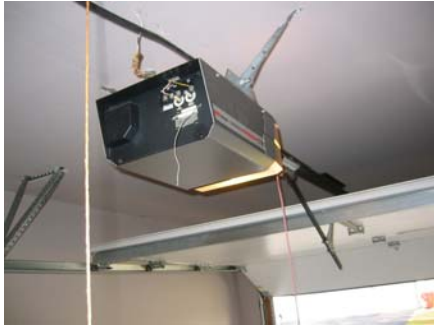
**SAFETY REVERSE AT GARAGE DOOR  
NOT FUNCTIONAL**

- **Safety reverse not functional on garage door operator. Recommend adjustment of existing unit or replacement as necessary.**

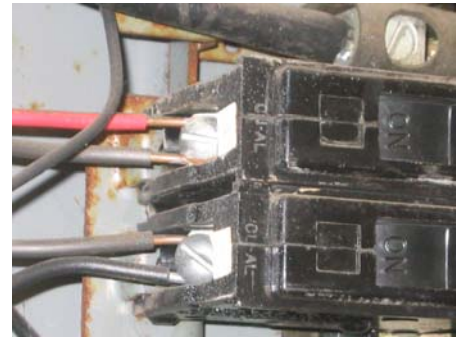
**HAZARDOUS DOUBLE TAP CIRCUIT  
WIRING AT MAIN PANEL.**

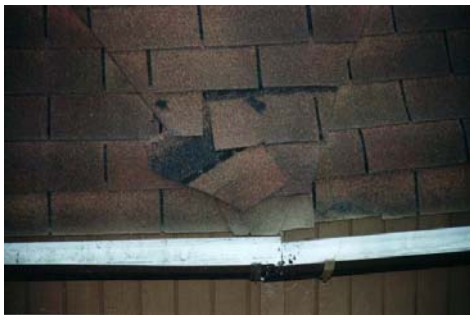
**ROOF SHINGLES DAMAGED AT  
GARAGE REAR ELEVATION**

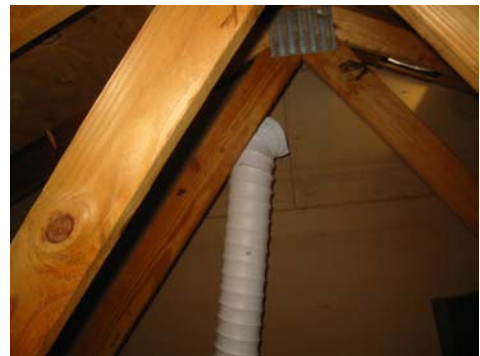
**BATHROOM EXHAUST VENT  
TERMINATES IN ATTIC RATHER  
THAN OUTSIDE**

- **Bathroom exhaust vent terminates in attic. Recommend properly routing to exterior.**

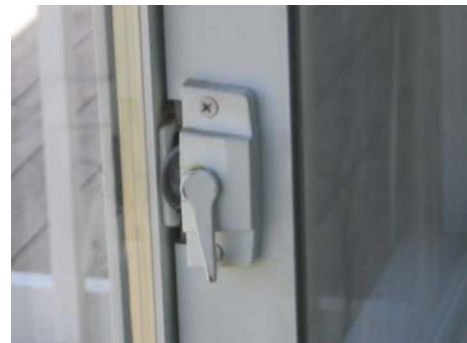
**WINDOW LOCK DEFECTIVE AT  
MASTER BEDROOM WEST WALL**
